PROJECT NOTE

SUBJECT: JARD Company, Inc.

TASK DESCRIPTION: Identification of Seeps in the Park Street Wetland Area

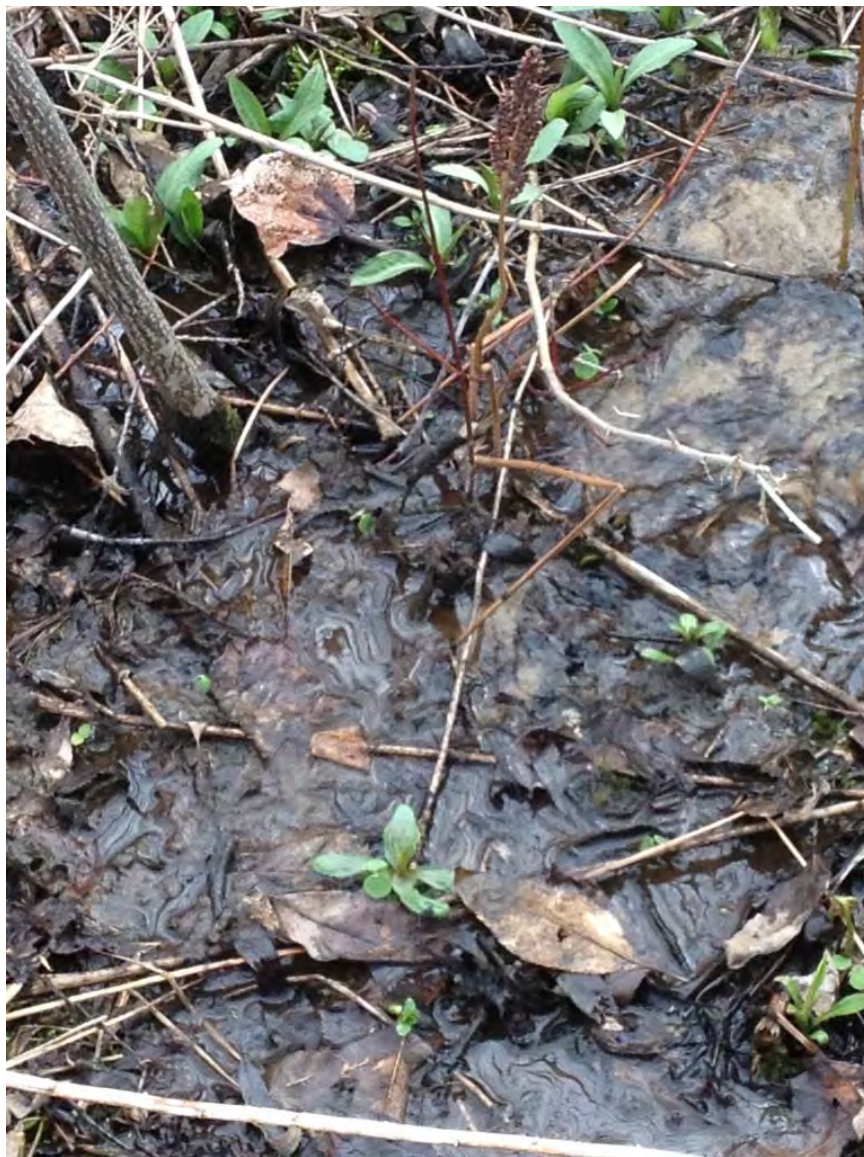
Attachment A

SCENE: View of groundwater seep in potentially impacted wetlands west of Park Street. Direction of flow is north to south. Photograph taken facing south.

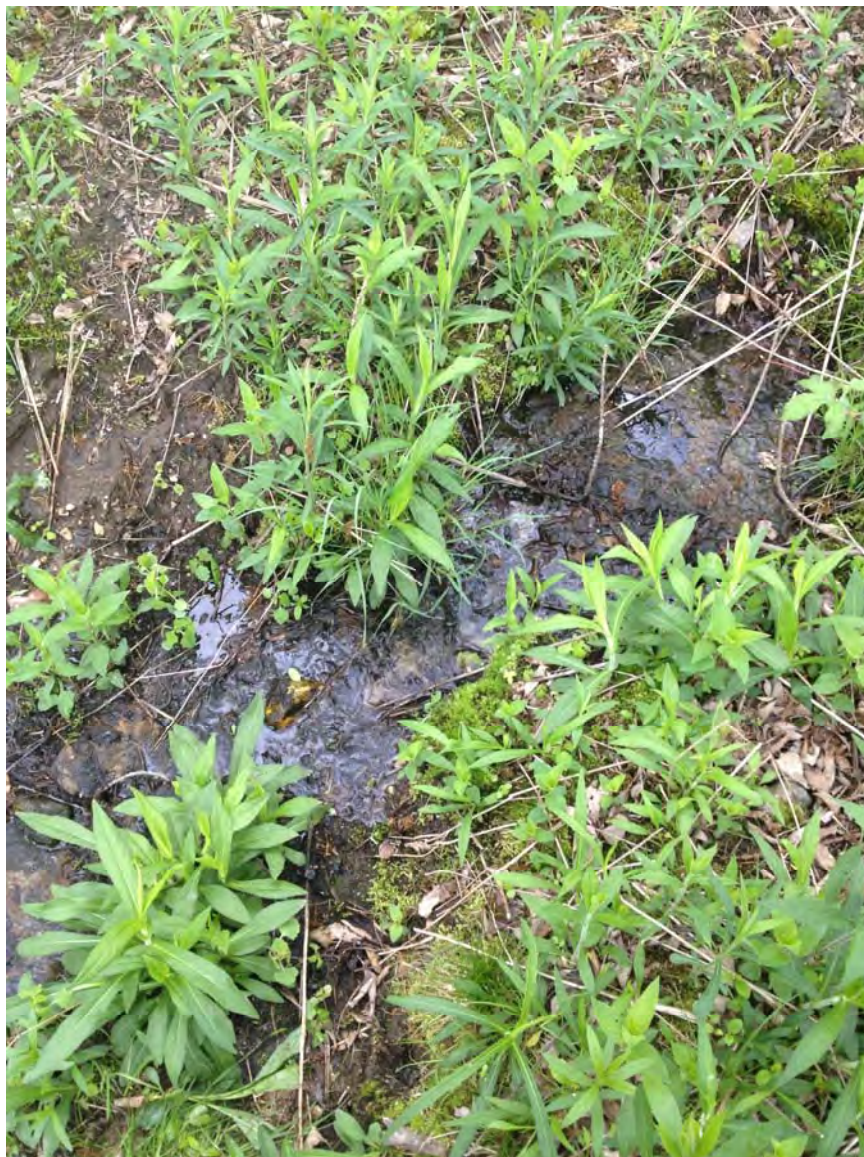
Attachment B

On 14 May 2013 START member Robinson returned to the potentially impacted wetland property located on Property P030 to conduct additional photo-documentation activities. START member Robinson observed and documented a second groundwater seep at 1142 hours at geographic coordinates 42.892333 north latitude and 73.1945 west longitude (see attachment B). This seep is located within a wetland area on the northern portion of Property P030, southeast of the open grassy area, and southeast of the open water body. At this location, START member Robinson observed and photo-documented water flowing up from the sediment floor, discharging into the wetland area on Property P030 (See attached photo – Attachment B).

SCENE: View of groundwater seep in potentially impacted wetlands west of Park Street. Direction of flow is southeast to northwest. Photograph taken facing east-southeast.
